# Cruiser's Renix Tips

Revised 12-28-2014

Created by Cruiser54

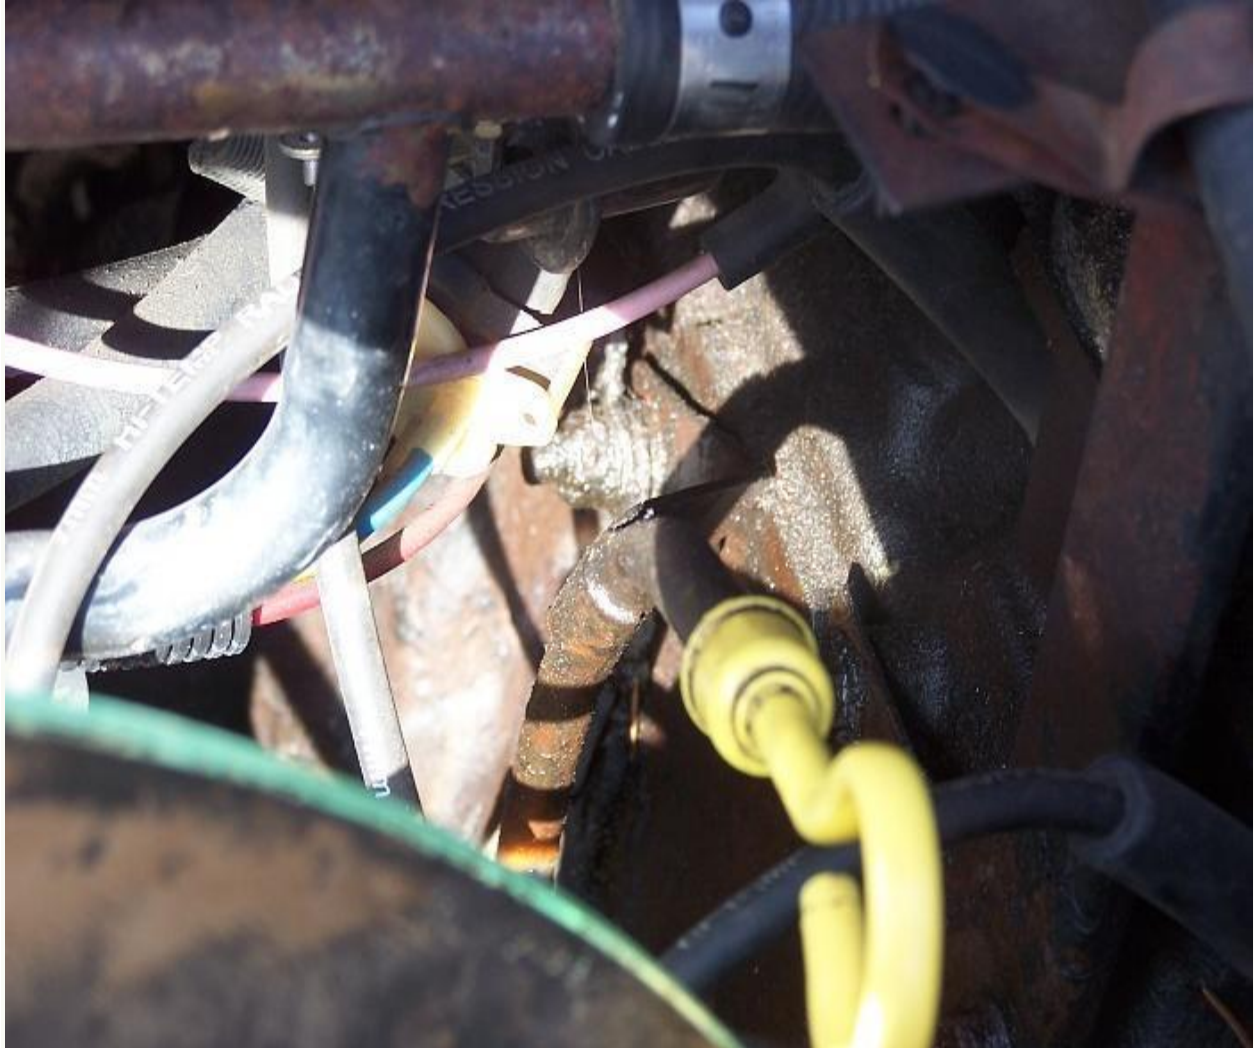
Be sure the crimps are tight. It wouldn't hurt to re-crimp them just as a matter of course. Sand and polish the wire terminals until clean and shiny on both sides. Reinstall all the wires to the stud and tighten the nut down securely.

While you're in that general area, locate the battery negative cable which is fastened to the engine block just forward of the dipstick stud. Remove the bolt, scrape the block to bare metal, clean and polish the cable terminal, and reattach securely.

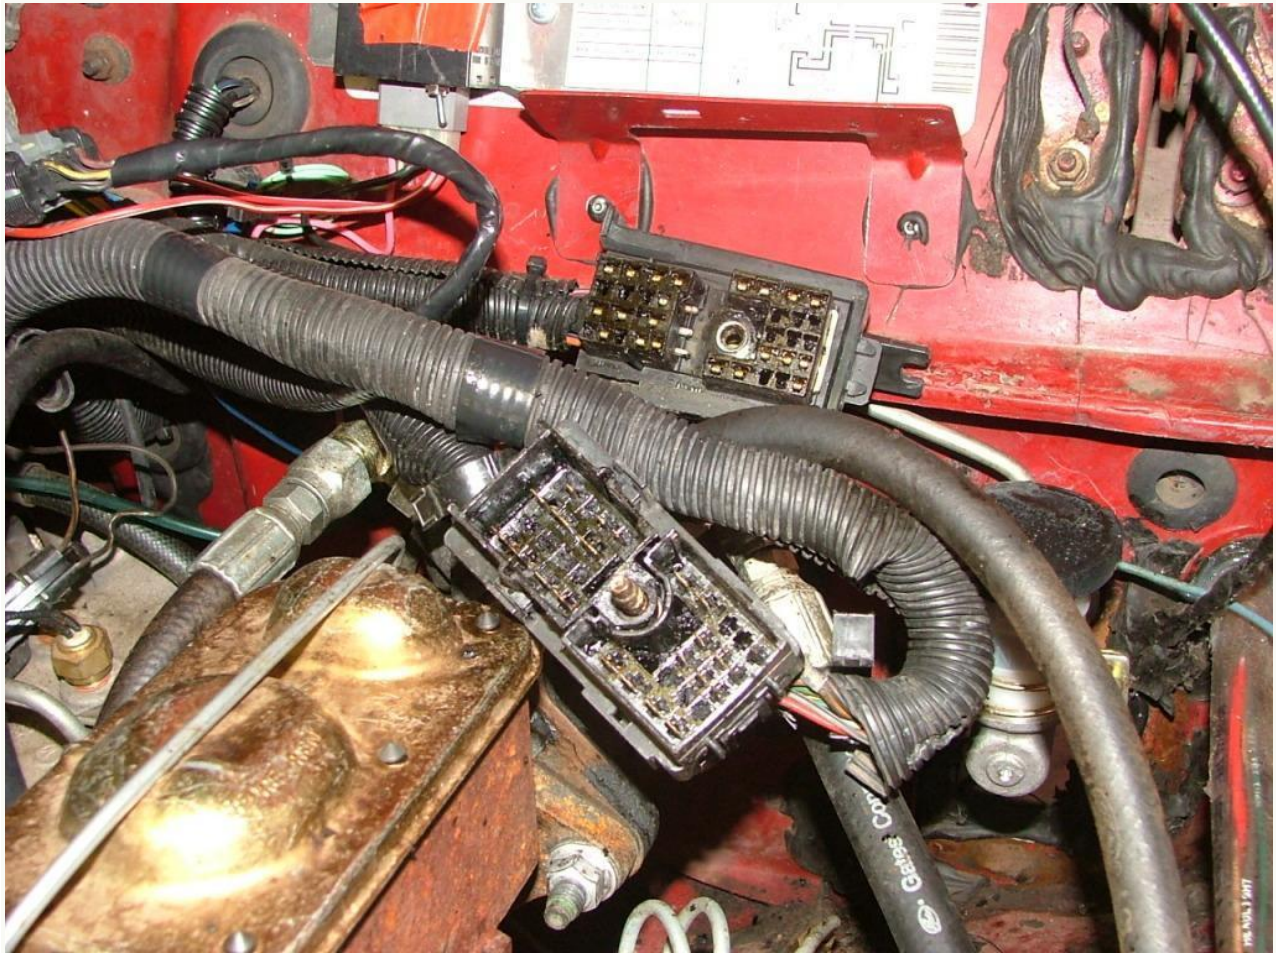
The C101 connector is located on the driver's side firewall above and behind the brake booster. It is held together with a single bolt in it's center. To get the connectors apart, simply remove the 1/4" bolt and pull the halves apart. You will find the connector is packed with a black tar like substance which has hardened over time.

Take a pocket screwdriver or the like and scrape out all the tar crap you can. Follow up by spraying out both connector halves with brake cleaner and then swabbing out the remainder of the tar. Repeat this procedure until the tar is totally removed. This may require 3 or more repetitions. Wipe out the connectors after spraying with a soft cloth.

If you have a small pick or dental tool, tweak the female connectors on the one side so they grab the pins on the opposite side a bit tighter before bolting both halves back together.

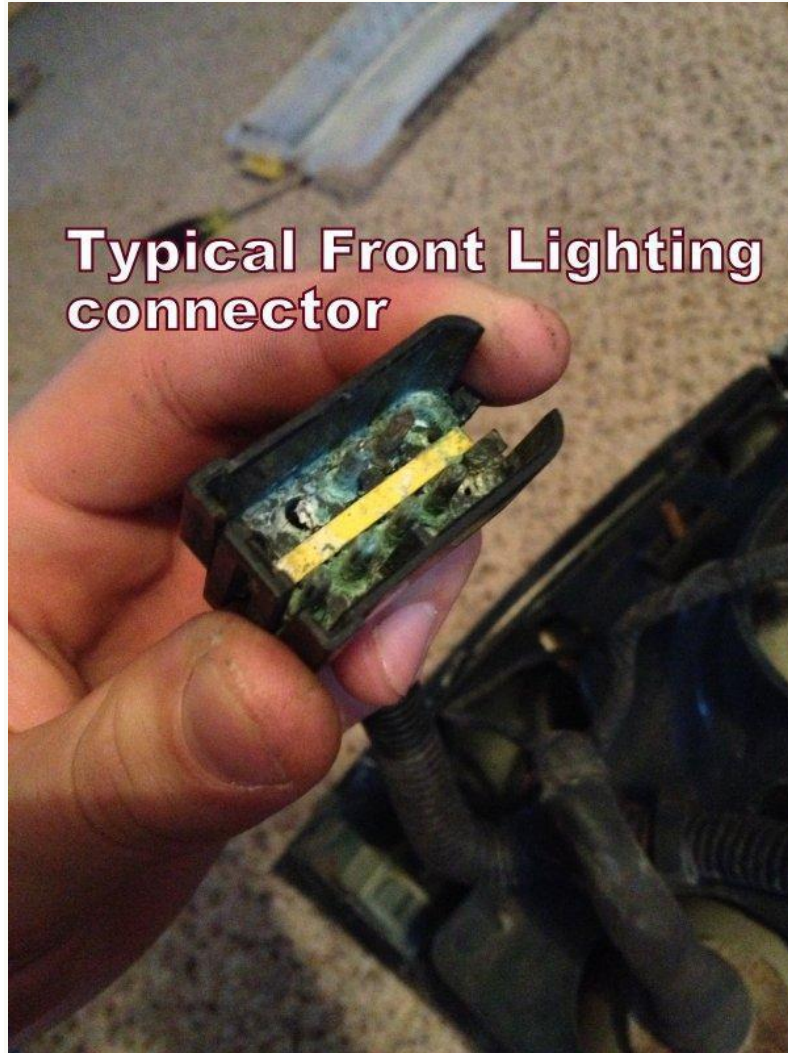
I suggest unplugging EVERY electrical connection in the engine bay you can find, whether engine related or not, and spraying it out with a good electronics cleaner, visually inspecting the terminals making sure they haven't retracted into the plastic holder, and then plugging it back together. There's a critical 10-pin connector for the front lighting system located in front of the air cleaner and behind the left headlight assembly. Don't miss that one. Also be sure that the connectors to the ballast resistor mounted near the air cleaner housing are clean and tight.

ALL of the relays should be removed, the terminals wire-brushed until shiny, and the receptacles sprayed out with contact cleaner. Then plug them back in. I do this on every Renix Jeep I purchase or work on for someone else.

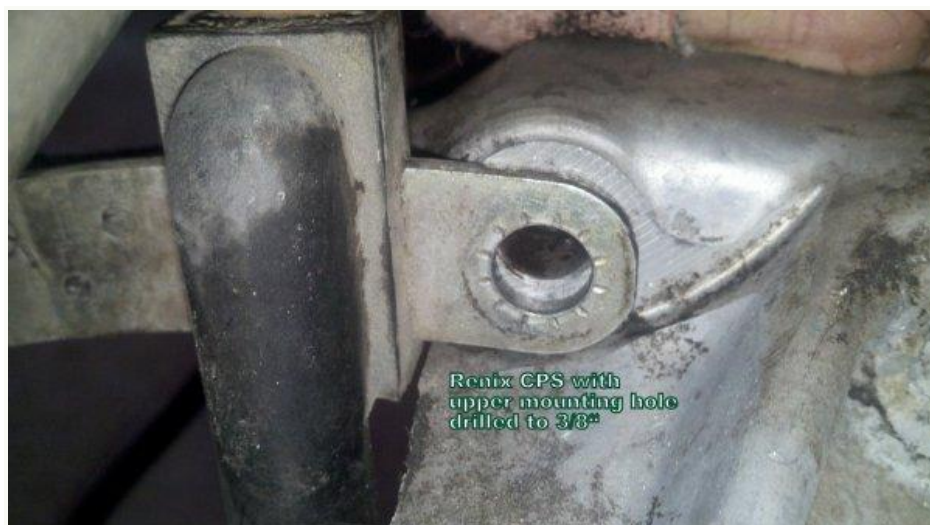
Sometimes on a manual transmission equipped Renix Jeep there is an accumulation of debris on the tip of the CPS. It's worn off clutch material and since the CPS is a magnet, the metal sticks to the tip of the CPS causing a reduced voltage signal. You MAY get by with cleaning the tip of the CPS off.

A little trick for increasing the output of your CPS is to drill out the upper mounting hole to 3/8" from the stock 5/16", or slot it so the CPS bracket rests on the bell housing when pushed down. Then, when mounting it, hold the CPS down as close to the flywheel as you can while tightening the bolts.

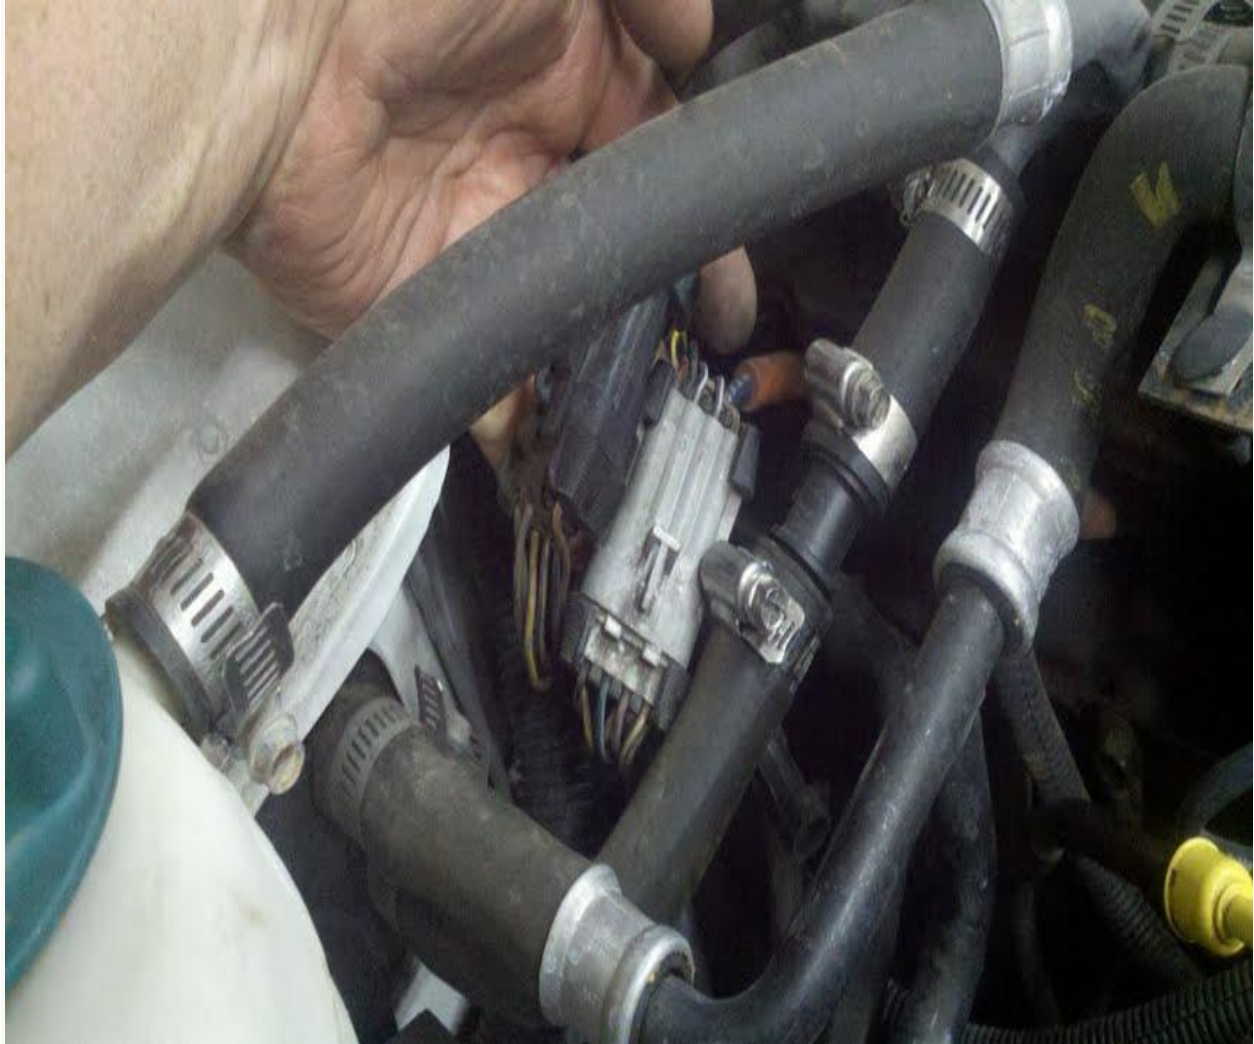
Over near the transmission dipstick tube are 2 rather large connectors. One is black and the other gray. These 2 connectors carry all the info between TPS, TCU, NSS, speed sensor, and transmission solenoids. Unplug each one, visually inspect for corrosion or bent pins, spray them out with electrical contact cleaner and plug them back in.

Additionally, if your Jeep is an 87 to 90 Renix, it's always a good idea to reach up under the glovebox area and unplug the connector to the TCU and spray it out along with the receptacle of the TCU. While you're there, find the fuse right in that area for the TCU. Remove it and spray out it's receptacle and clean any corrosion from the fuse.

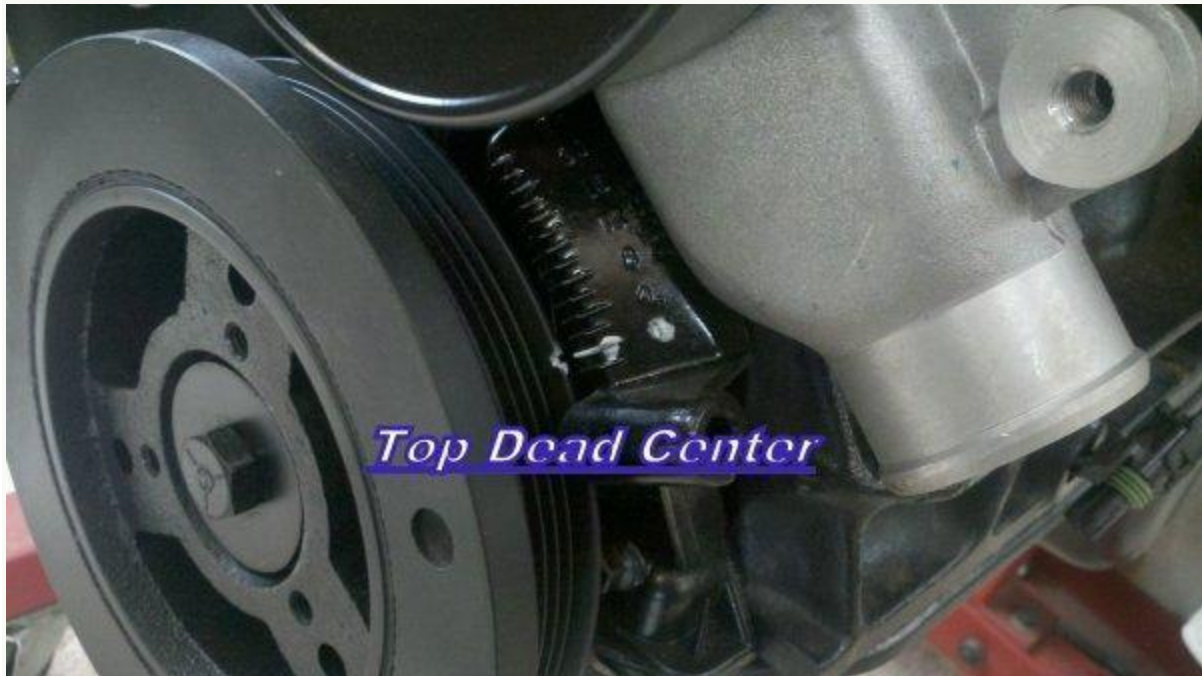
With #1 spark plug removed, turn the engine over clockwise using the 3/4" front crankshaft bolt. You will see the degree marks on your front cover. Mark the 0 with chalk or white-out. You will see the timing mark on the balancer. Mark it with chalk or white-out. While turning the engine over, put your finger/thumb over #1 spark plug hole. As the mark on the balancer approaches the marks on the front cover, if you are coming up on #1 TDC, pressure in the cylinder will push on your finger. If there's no pressure, you're at #6 TDC and need to crank the engine over until you see the marks coming together and you get pressure. Set the mark on the balancer to the 0 mark on the front cover.

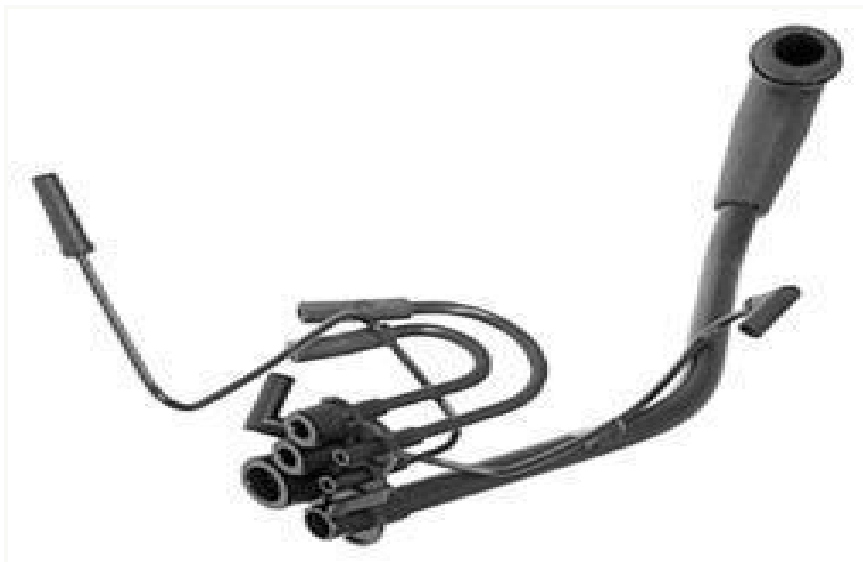
The vacuum harness that attaches to the front of the valve cover and includes the grommet/fitting, and is called the front harness, is Napa part number BK 715-1367, or Dorman 46003.

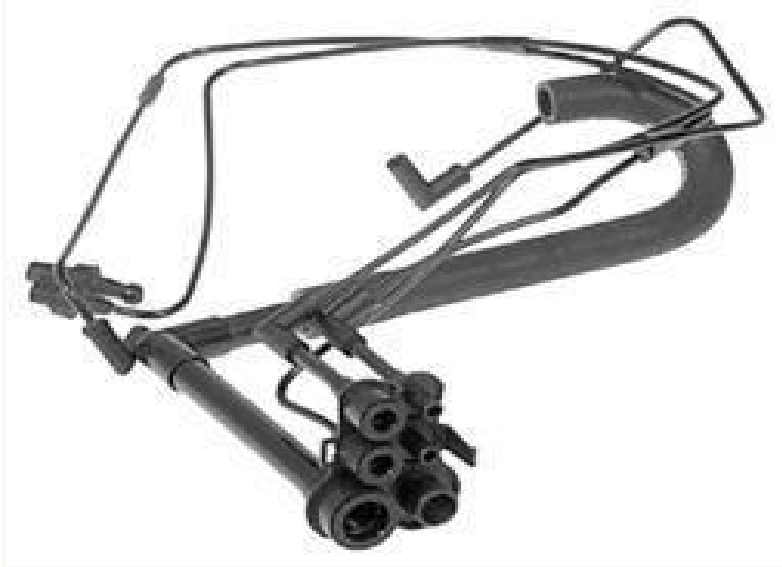
The vacuum harness that is closest to the air cleaner, EGR etc, and is called the rear harness, is Napa part number BK-715-1366.or Dorman 46004

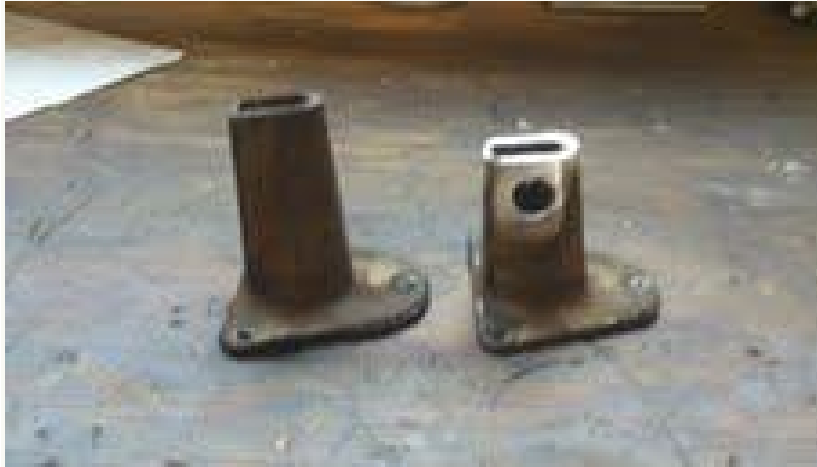
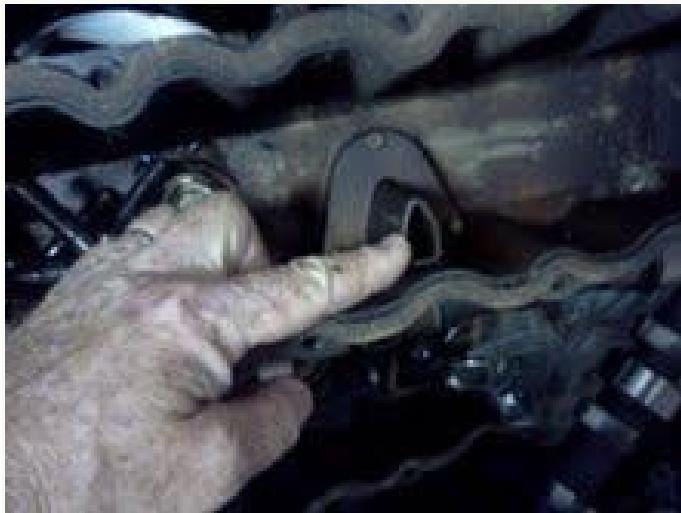
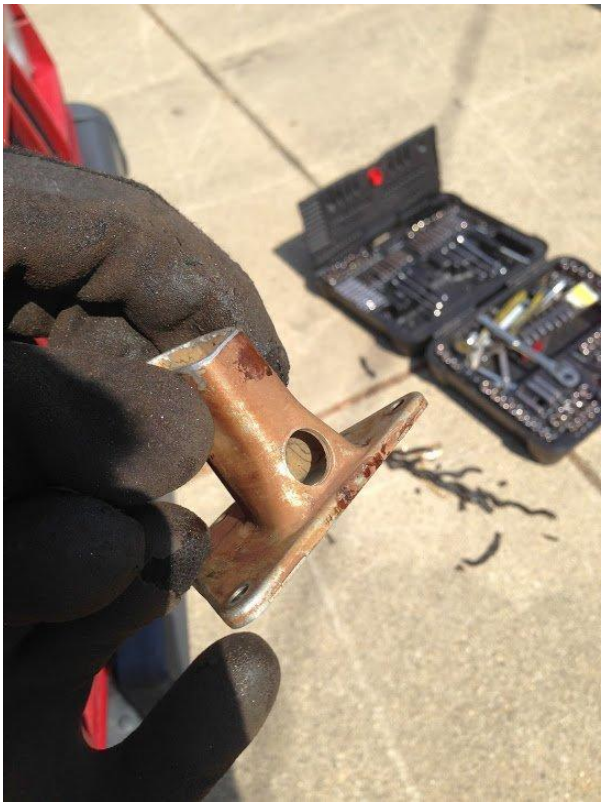
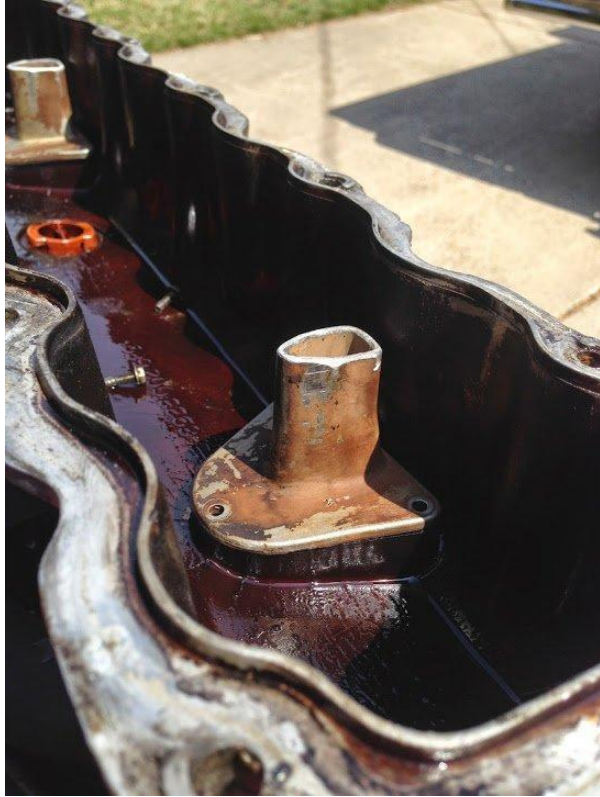
Remove the valve cover and turn it over. Next, remove the fluted tubes that are now facing you by removing three screws on each. Chop 1 inch off each of them. Then, about a half inch up from the area where you just sawed them off, drill a half inch hole in the tubes so the holes will face the rear of the valve cover. Clean and de-burr/sand all rough edges nicely, clean with solvent, and reinstall. Don't be concerned about the chintzy gaskets that will probably crumble into oblivion when you remove the fluted tubes. They can go back together without gaskets.
